State of Utah

Division of Oil, Gas and Mining
JOHN R. BAZA
Division Director

Minerals Inspection Report

Mine Name: Antelope Quarry	Permit Number: S/039/0018	Mine Status: Reclaimed
Operator Name: Bown Stone Products Inc.	Inspection Date: 06/17/2014	Permit Fees: No Fee Req.
Inspector(s): Peter Brinton	Inspection Time: 1:30pm - 2:15pm	Bond Amount: \$18,600
Attendee(s): none	Weather: overcast, warm	Bond Escalation: n/a
Inspection Purpose: Operator requested bond release		Prior Inspection: 04/03/2014

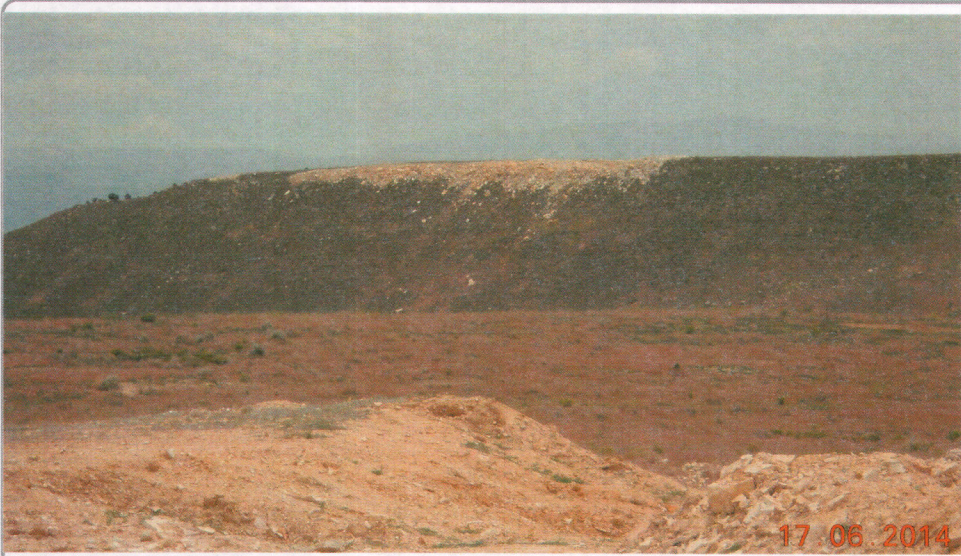
2. <i>Public Safety (shafts, adits, trash, signs, highwalls)</i>	<input checked="" type="checkbox"/>	<input type="checkbox"/>
Outslopes in both quarry areas are steep and still somewhat loose, but no unreasonable conditions affecting public safety exist. Adjacent natural slopes are steep, with relatively minor natural rockfall ongoing.

3. <i>Protection of Drainages/Erosion Control</i>	<input checked="" type="checkbox"/>	<input type="checkbox"/>
Fallen boulders and dump slopes extend off the ridge and partly down the hill. Given the nature of the pre-mining and adjacent natural slopes (steep, with natural - though fewer - boulder falls) and the lack of any significant upslope area to generate flows (since the crest of the slope is the natural high point), no significant erosion concerns are present. The culvert, and the fill in the dry channel at the beginning of the access road have been removed, and the natural channel re-established

Northeast quarry, looking south from the nearby community pit. Note the rock piles and fallen rock.

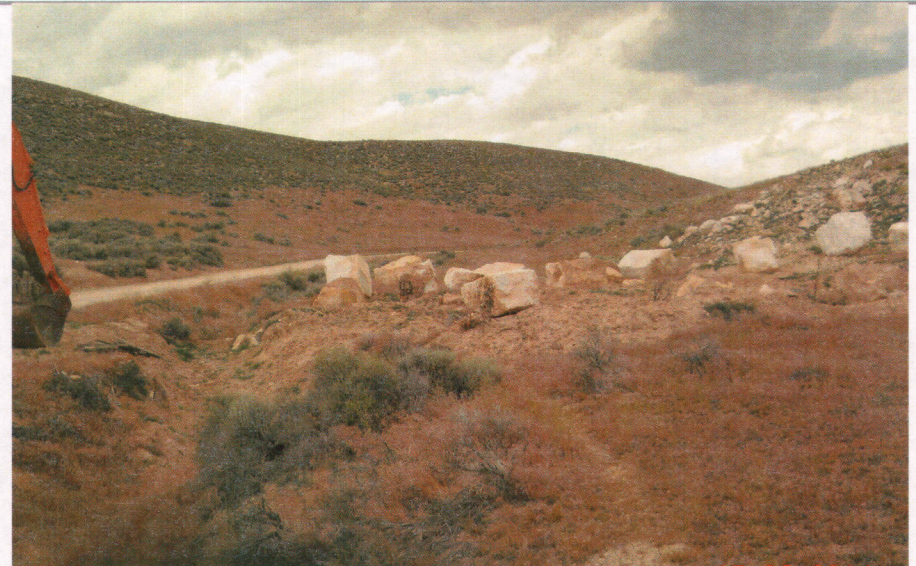
Re-established drainage (left) at the site entrance, and the graded, weedy access road on the right.

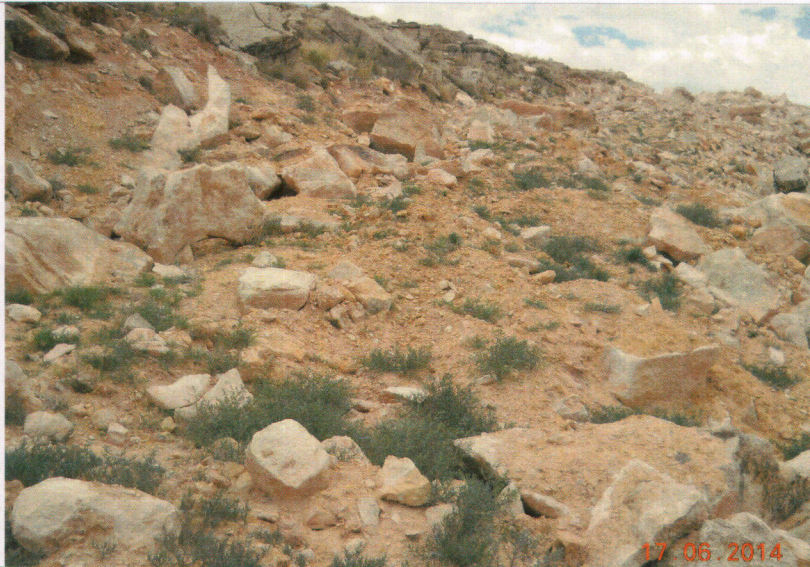
9. <i>Revegetation</i>	<input checked="" type="checkbox"/>	<input type="checkbox"/>
No species recommended for seeding were observed. Predominantly weedy species are growing on graded areas, included halogetan, Russian thistle, and cheatgrass. The undisturbed areas surrounding the disturbances is a mix of both weedy species and beneficial species, with large weedy areas located to the north of the hill.

Section of contoured access road with first year's weed growth.

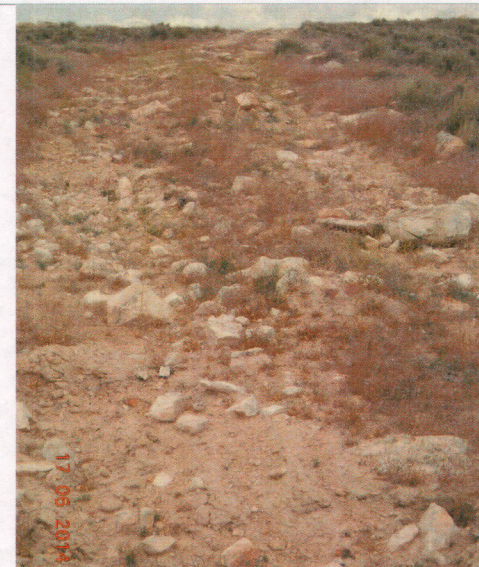
Graded access road with cheatgrass and other weeds across the hilltop between the southwest and northeast disturbances.

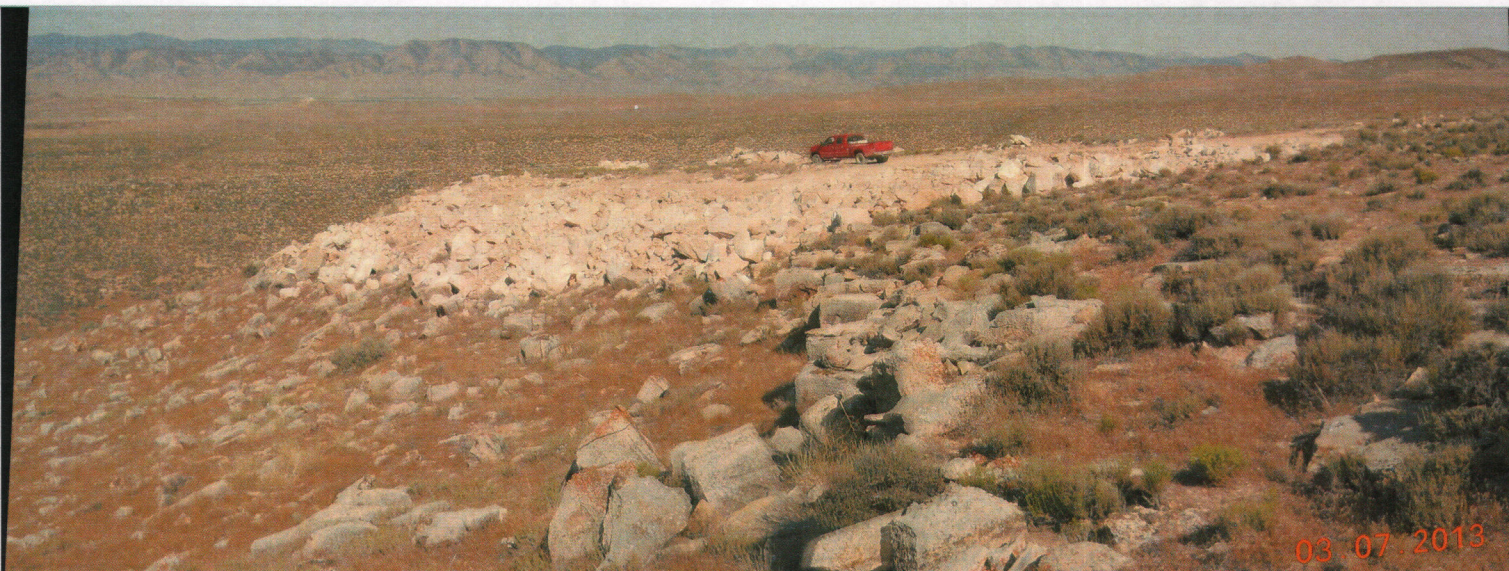
6. <i>Reclamation</i>	<input type="checkbox"/>	<input type="checkbox"/>
7. <i>Backfilling/Grading (trenches, pits, roads, highwalls, shafts)</i>	<input checked="" type="checkbox"/>	<input type="checkbox"/>
Quarry areas were acceptably backfilled, and the operators did a good job of recontouring as a whole, given site conditions. Large blocks of stone remain exposed or on top of the natural ground surface in some parts, and a depression in the northeast quarry was left which could have been more completely filled with nearby graded rock piles that rise above the natural surface. However, the natural surface of the site would have had significant amounts of exposed stone prior to mining, and the post-mining land use of the graded site will be similar to that of the pre-mining land use, and, in this case, it was decided that no additional work is needed. Roads cuts have been graded, and the roads on the top of the hill between quarries have been roughened.

Regraded disturbance along the southwest crest of the hill, looking northwest. Note the rocky slopes and rock outcrop that would be characteristic of pre-mining conditions. Photo was from the July 3, 2013 inspection. Stitched photo.

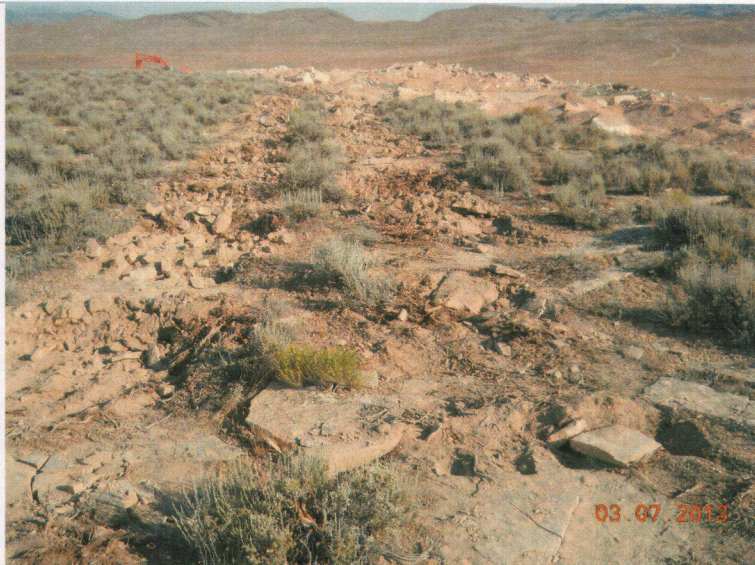
Roughened road connecting the small northeast site with the larger. Photo was from the July 3, 2013 inspection.

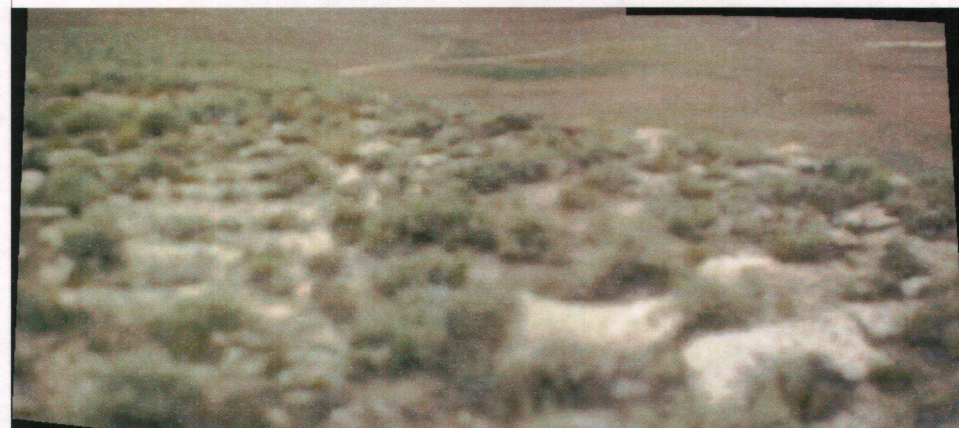
8. <i>Soils</i>	<input checked="" type="checkbox"/>	<input type="checkbox"/>
Along the hill crest and adjacent to the quarry, soils are thin to non-existent. Where limestone is exposed at the surface, sagebrush and some other plants grow only in cracks in the limestone. As part of reclamation in the parts of the northwest disturbance, soils that reportedly were naturally deposited in a gap between bedrock and the crest were excavated and spread to help cover the graded rock. In some areas, significant broken rock remains uncovered, and revegetation may be more difficult. The post-mining land use should not be significantly different from that of adjacent undisturbed areas, but it is possible additional revegetation work and time may be needed before beneficial species will be established.

Conditions adjacent to the northwest end of the northeast disturbance, looking off the crest to the northwest. Note the exposed limestone bed at the surface with no soil.

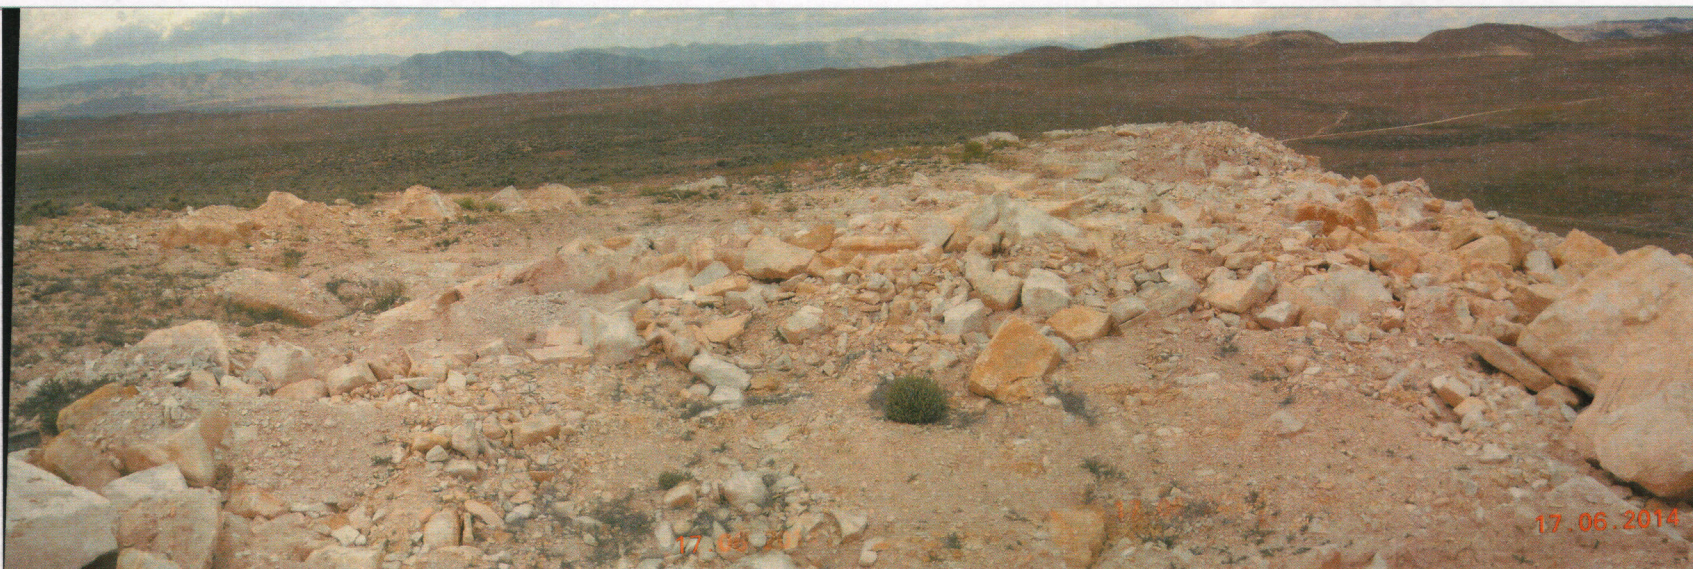
Rocky graded area looking northwest along the northeast crest of the hill. Note the significant rock with some fines. The depression is to the rear of the stitched photo, and some of the foreground material could have been pushed into the depression more.

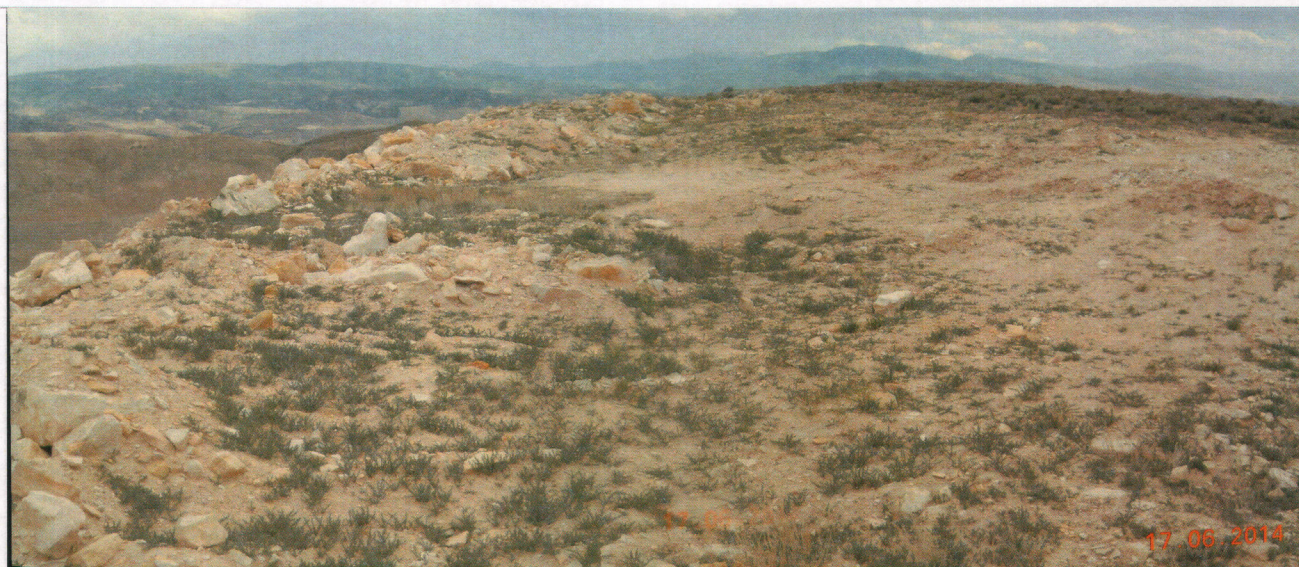
Graded area primarily covered with soils and weeds looking southeast along the northeast crest of the hill. Stitched photo.
